# *Fifty-four years of ephemeral channel response to two years of intense World War II military activity, Camp Iron Mountain, Mojave Desert, California*

Nichols, K.K., and Bierman, P.R., 2001, Fifty-four years of ephemeral channel response to two years of intense World War II military activity, Camp Iron Mountain, Mojave Desert, California, *in* Ehlen, J., and Harmon, R.S., eds., *The Environmental Legacy of Military Operations*: Boulder, Colorado, Geological Society of America Reviews in Engineering Geology, v. XIV, p. 123–136.

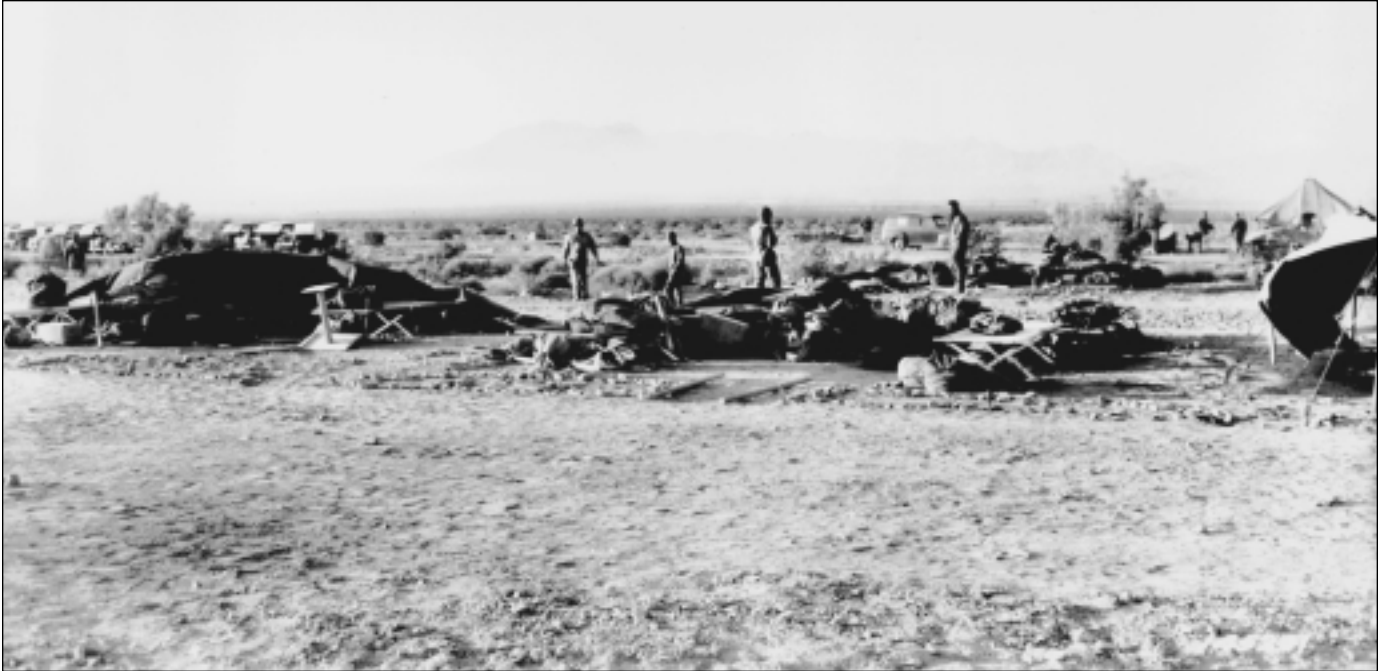
Figure 2. Photograph of Camp Iron Mountain after a sandstorm. Rock alignments are visible in front of tents. After camp abandonment, rock alignments were left intact. Foot and vehicle traffic has obliterated ephemeral channel network. National Archives photo #111-SC-145201.

Historic photographs document that constant foot, vehicle, and tank traffic destroyed most, if not all, of the small channels

during the occupation of Camp Iron Mountain (Fig. 2). Thus, we can reasonably assume a surface absent of channels inside the camp when our experiment began in May 1944. We assume that road berms and rock alignments were intact at the time of evacuation. Because the area is remote and the nearest populated town is more than 55 km away (Desert Center, California, population 120), post-army activity is limited to natural processes (overland flow and bioturbation) and occasional off-road vehicle (ORV) use. Around 1980, a fence was constructed around Camp Iron Mountain that stopped all ORV traffic (Bureau of Land Management, 1986).

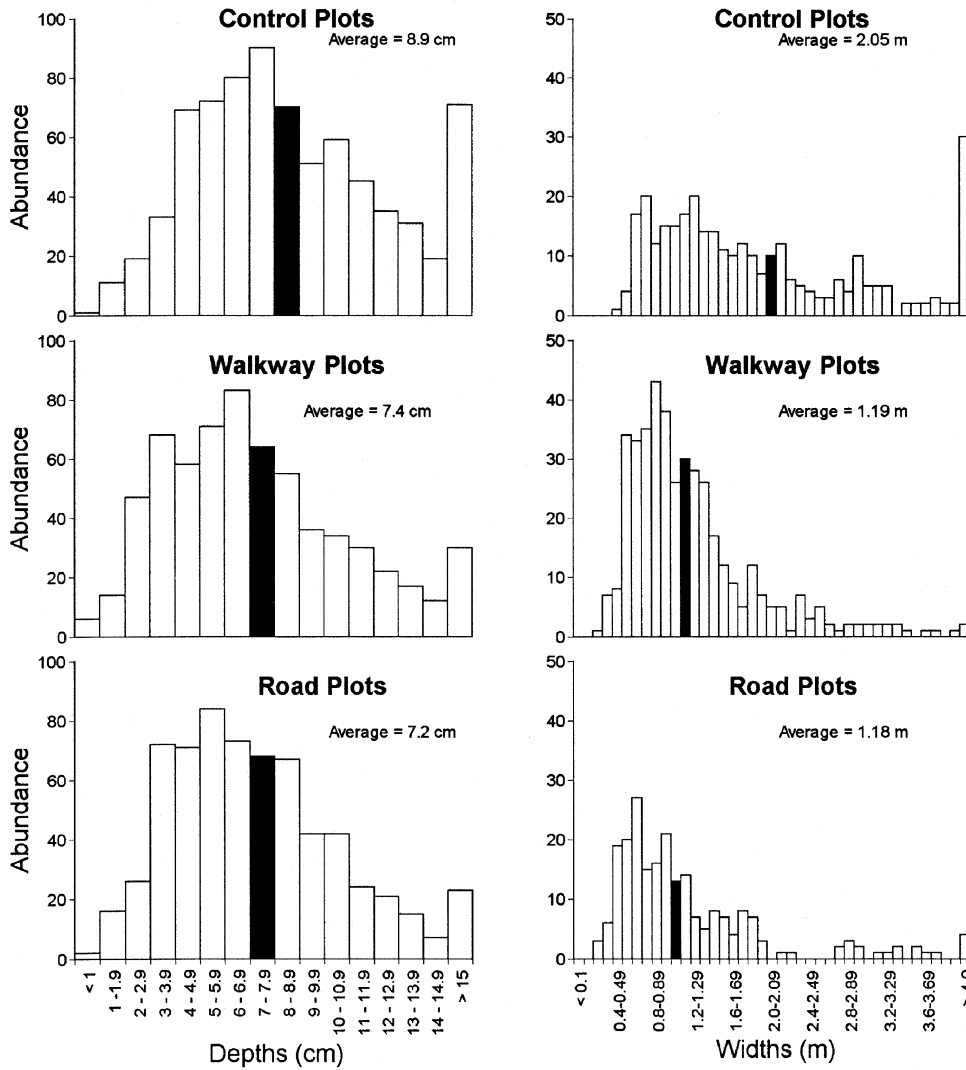
Figure 3. Distribution of channel depths and widths for control, walkway, and road plots. The black bar represents mean value.

walkway and road plots are not statistically different ( $t = 0.65$ ,  $df = 1272$ ,  $P > 0.52$ ). Data for all plots are right skewed (Fig. 3).

Channels in control plots are significantly wider (99.9% confidence level) than channels in walkway ( $t = 9.29$ ,  $df = 428$ ,  $P < 0.001$ ) and road ( $t = 8.53$ ,  $df = 531$ ,  $P < 0.001$ ) plots. Control plot channel widths average  $2.05 \pm 1.48$  m ( $n = 319$ ). Average channel widths for walkway and road plots are  $1.19 \pm 0.71$  m ( $n = 418$ ) and  $1.18 \pm 0.61$  m ( $n = 224$ ), respectively (Table 2). Widths of channels in walkway and road plots are not statistically different ( $t = 0.58$ ,  $df = 372$ ,  $P > 0.56$ ). Control plot channels have a greater range in widths compared to widths in disturbed plots. Data are skewed to the right for all plots (Fig. 3).

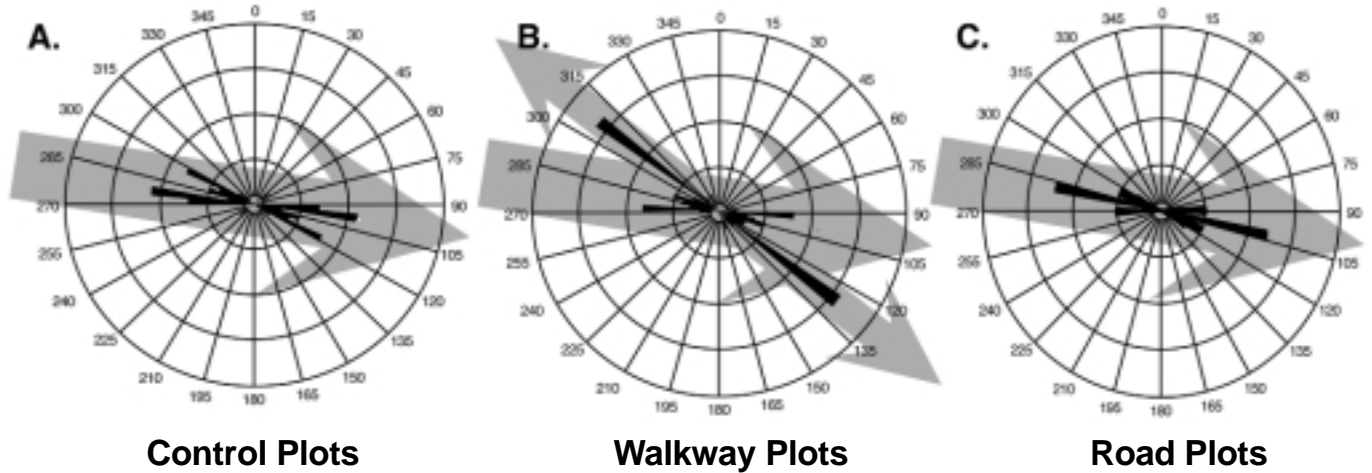
Figure 4. Rose diagrams of channel orientations. The light gray arrow represents the average orientation of the steepest topographic gradient for all plots. Each successive larger circle represents five channels with the same orientation. A: Control plots B: Walkway plots (smaller, double barbed arrow represents walkway orientation) C: Road plots.

Channel orientations in road plots are less variable than channel orientations in walkway and control plots (Fig. 4). The road plot channels have a uniform surface with few flow obstruc-

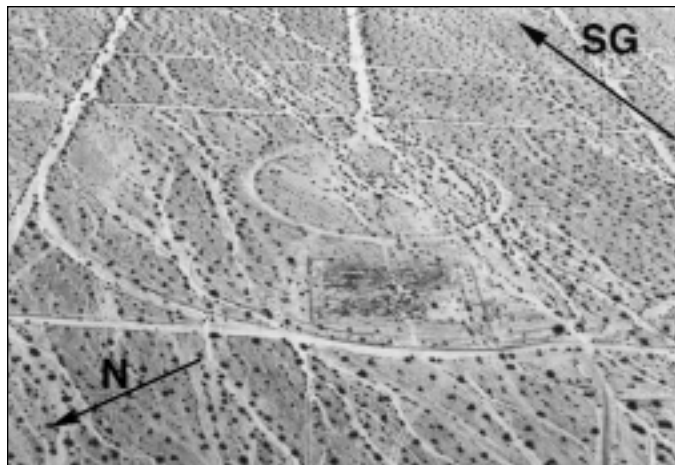
Figure 8. Low-level oblique aerial photograph of Camp Iron Mountain showing road berms channeling flow. Crossroads that are oriented down steeper gradients become wide washes. Roads are ~7 m wide. SG—Steepest gradient (from H. Wilshire).

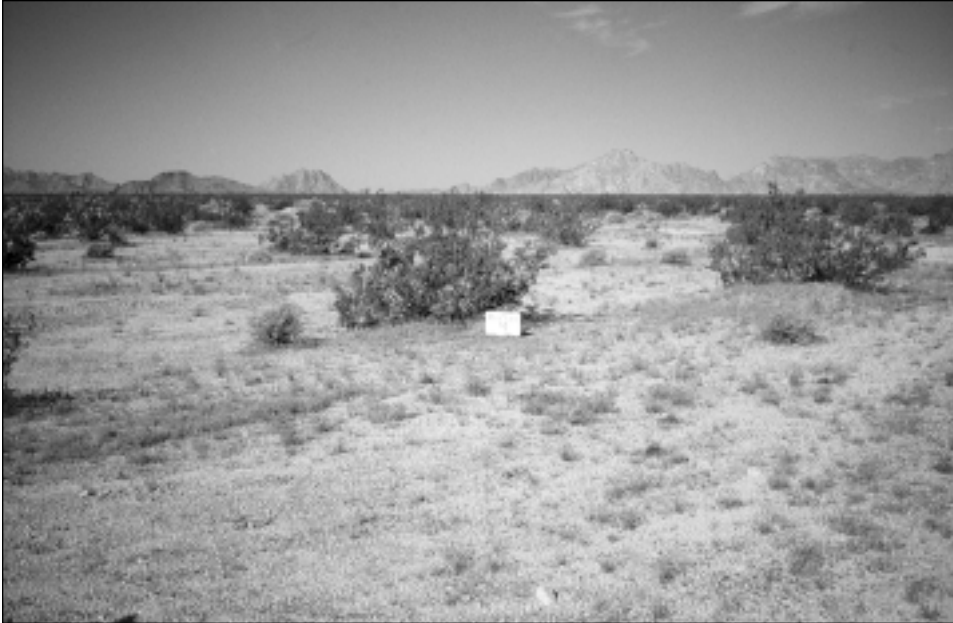
Figure 9. Photograph of the smooth surface below an intact road berm on map C-4. This area, devoid of channels, is dominated by sheetwash. Bush in center of photograph is ~2 m high.

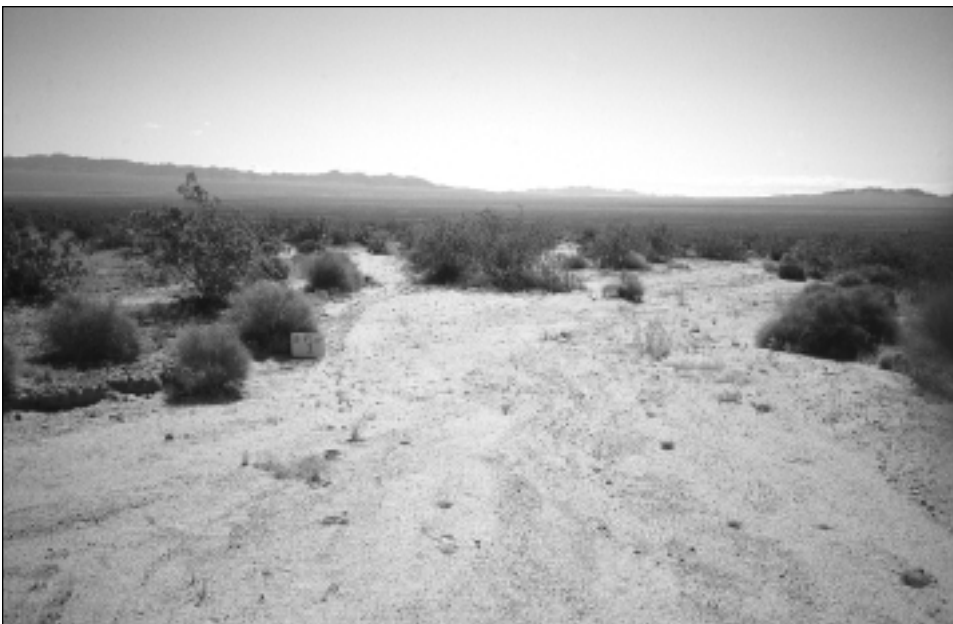
Figure 10. Photograph of a wide, braided channel down gradient of a breached berm in R-1. Bush in front left is ~80 cm high.

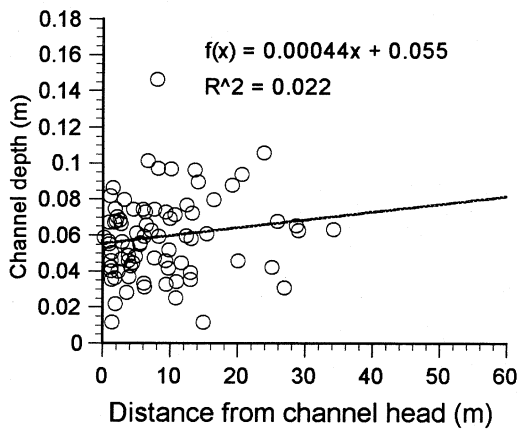
Figure 12. Channel widths and depths as a function of distance from channel head. Low slopes of linear models and poor correlation imply that channels widen slightly but do not appear to deepen significantly down piedmont
