BORN-AGAIN GULLY: THE REESTABLISHMENT OF THE MILLER BROOK GULLY, NORTHERN VERMONT

EATON, Derek F. and NICHOLS, Kyle K., Department of Geosciences, Skidmore College, 815 N. Broadway, Saratoga Springs, NY 12866, d_eaton@skidmore.edu

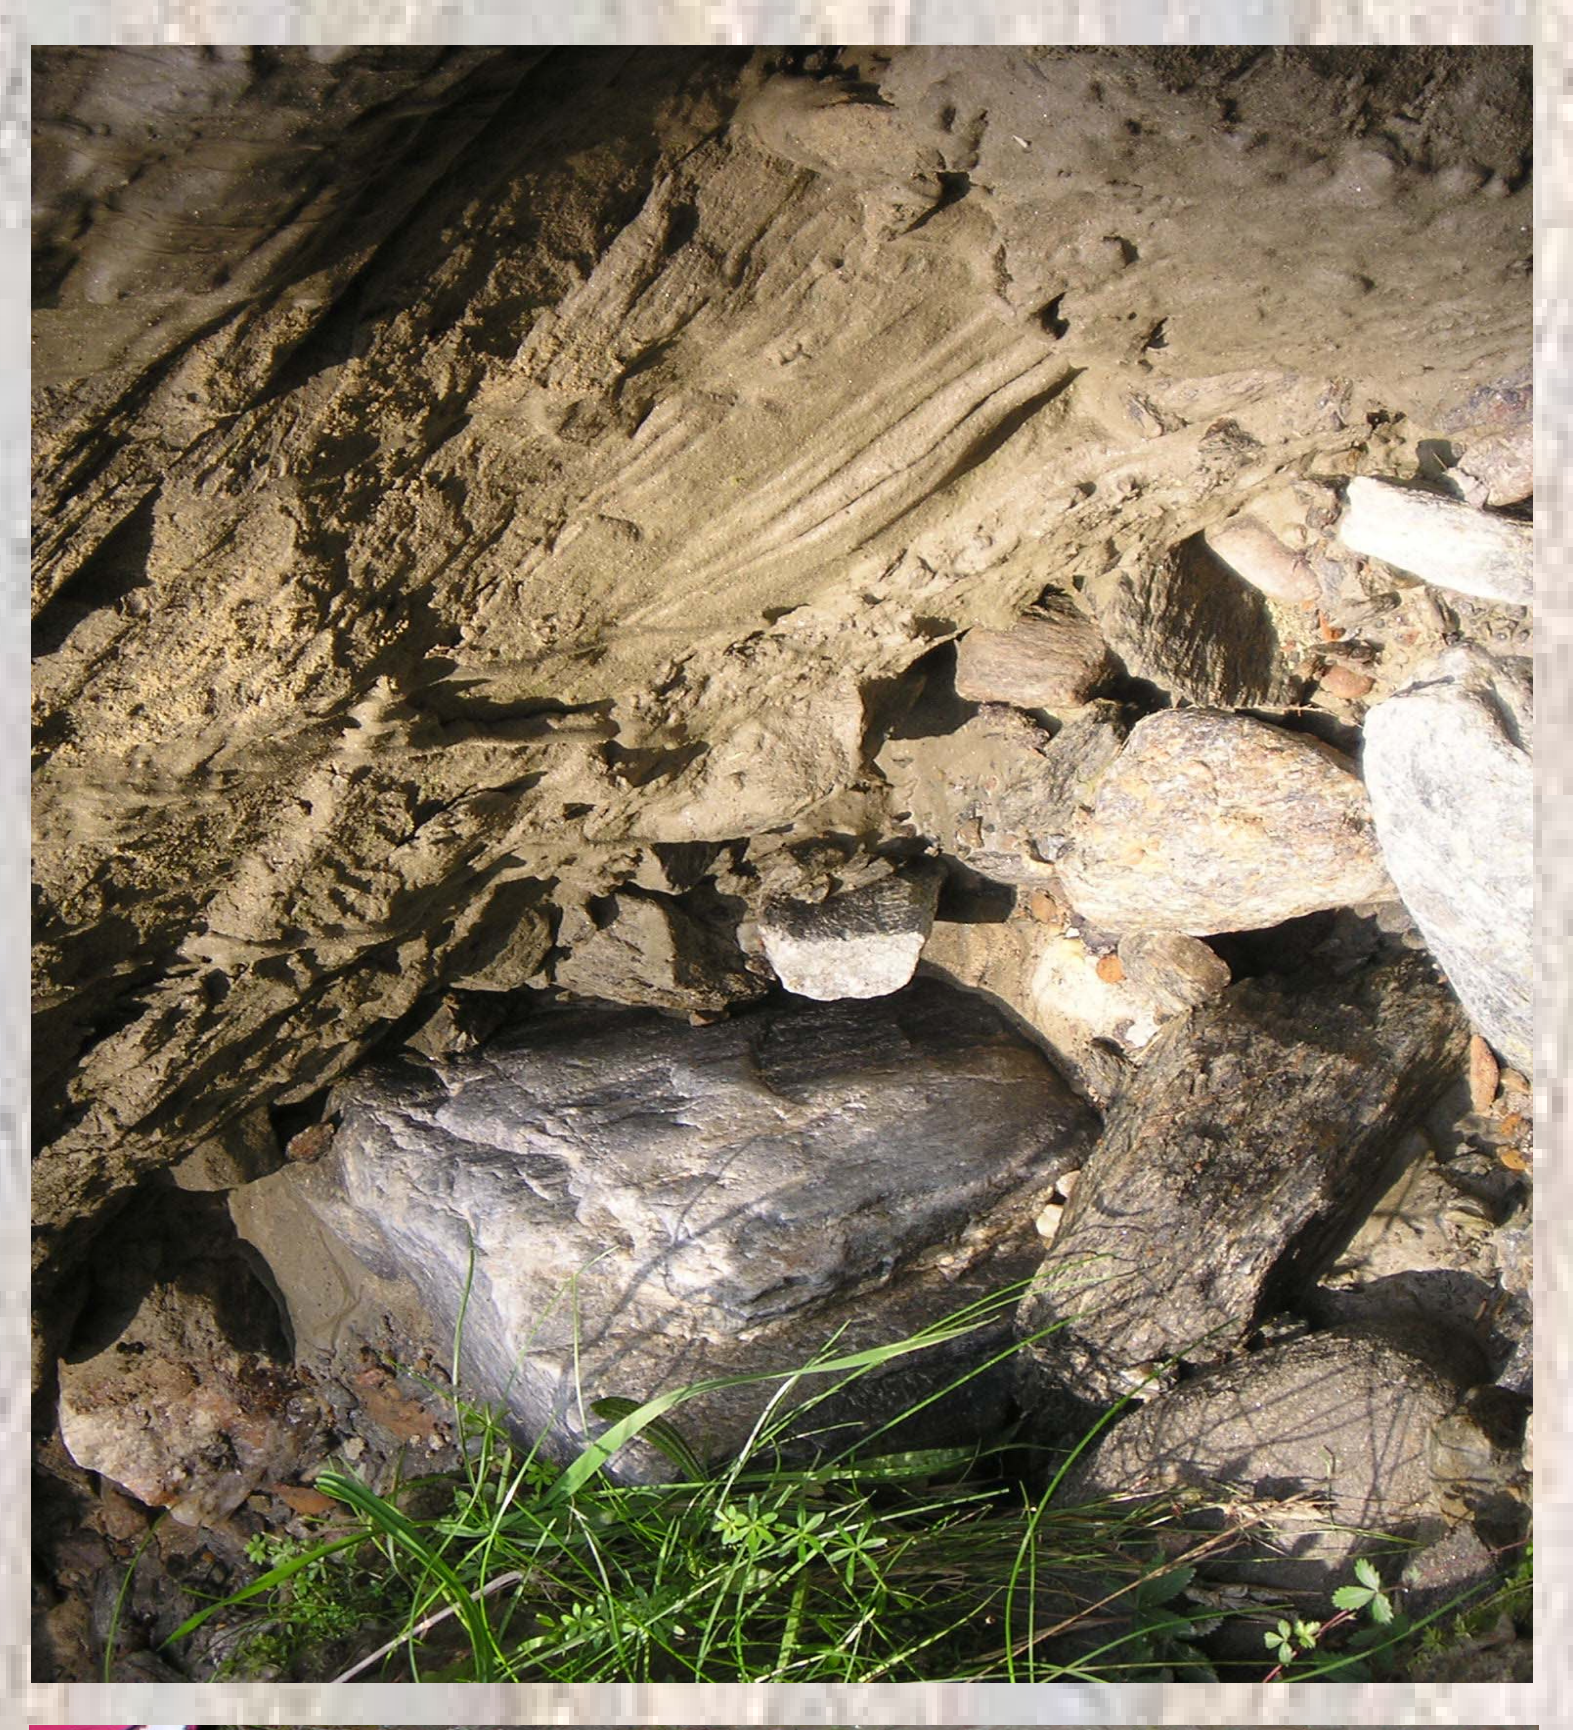
Lacustrine clays overlying till

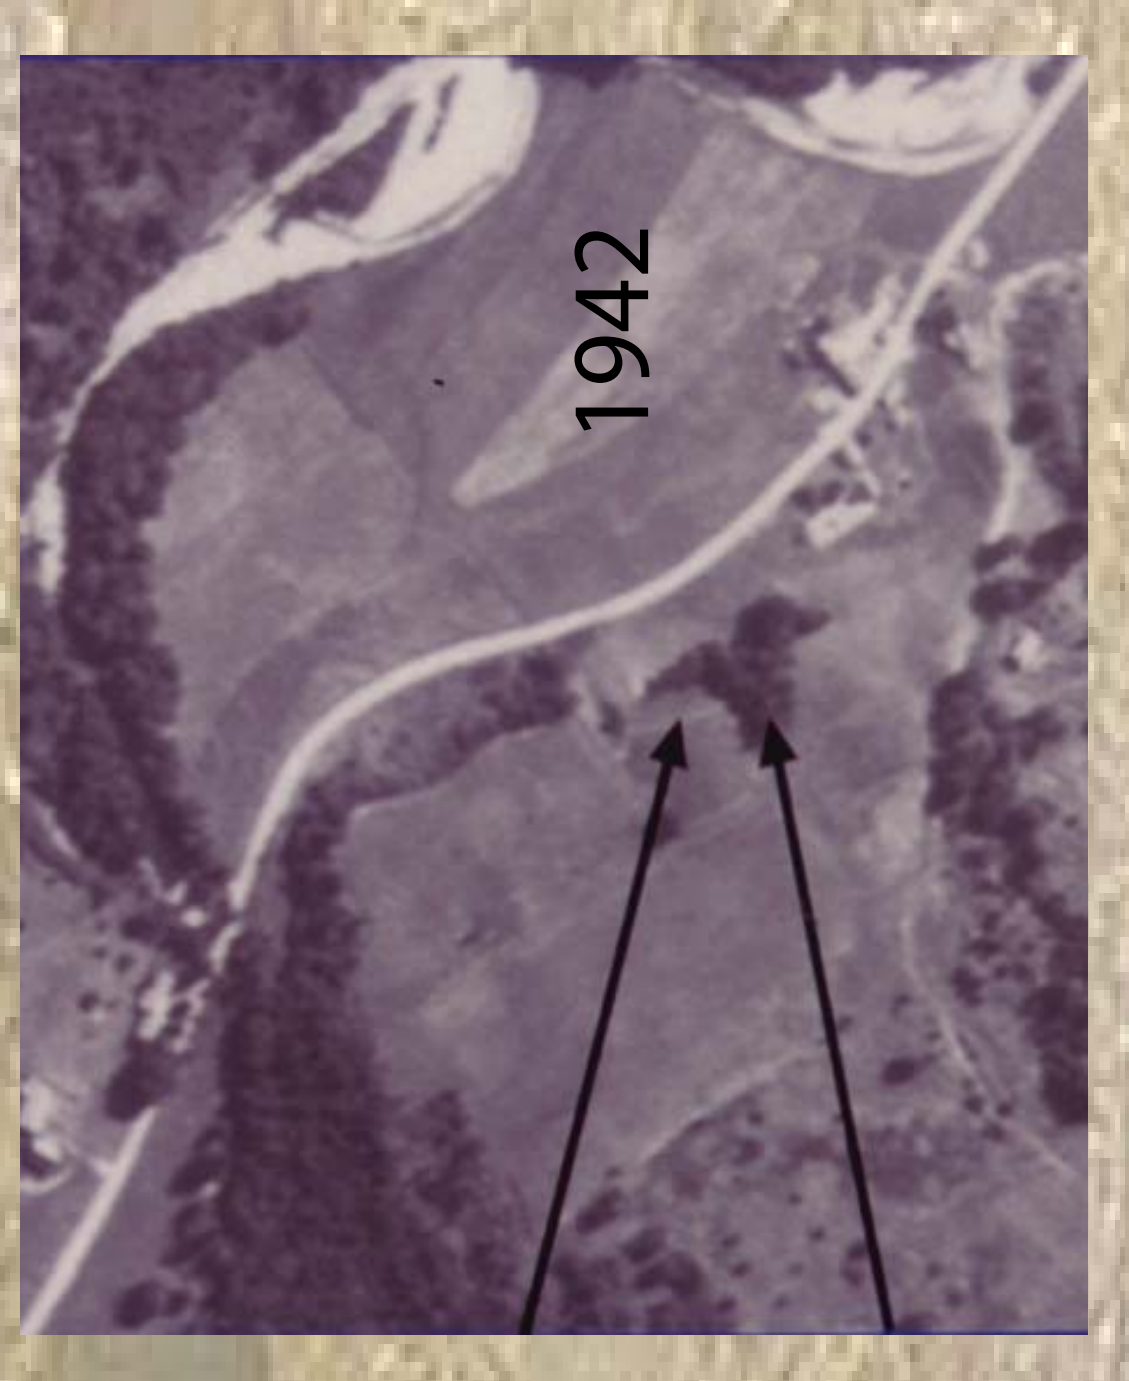
1942

Top arrow in each photograph shows location of active gully
Bottom arrow in each photograph shows location of stable gully

- Hillslope above gully has been extensively logged in the past (town records from 1856)
- Logging ceased in the late 1970s and commenced again in 2000 to 2001
- Gully became active sometime in the late 1960s to early 1970s
- Road moved from base of hillslope sometime between 1963 and 1978 (because of alluvial fan activity?)
- Stable gully that bottoms on till is ~100 m south of active gully

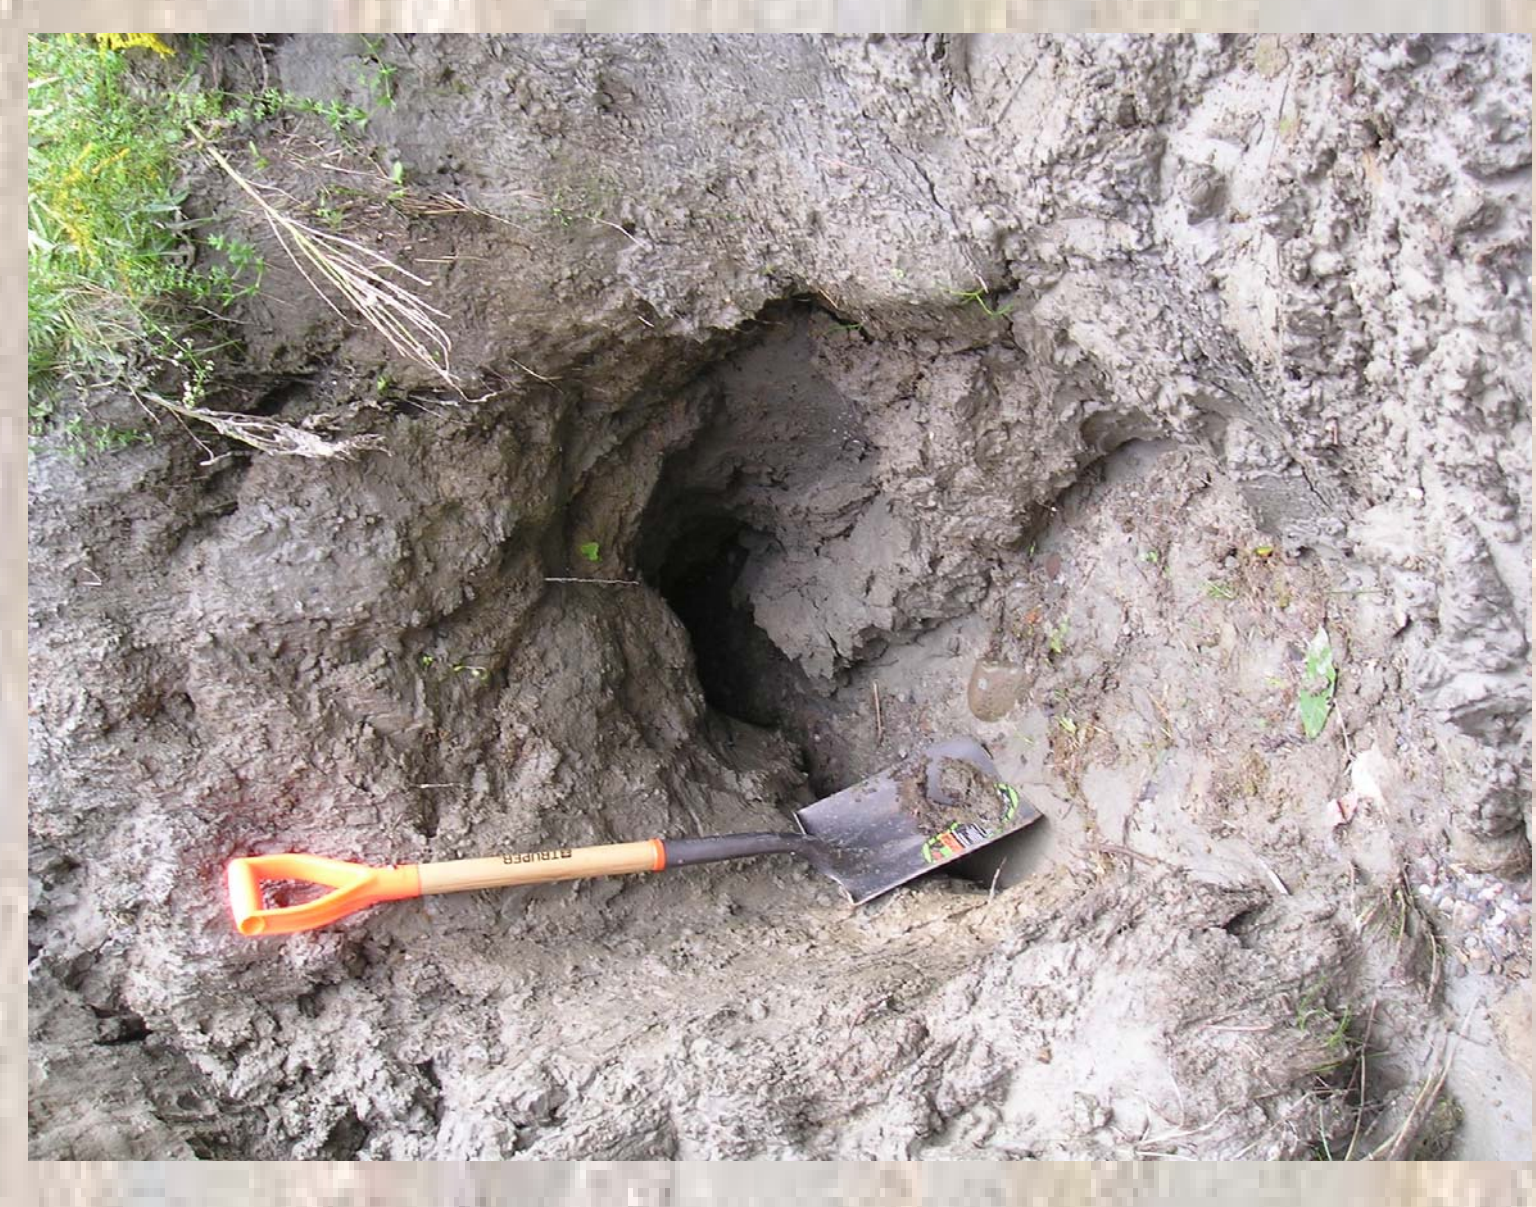
Collapsed pipe at bottom of gully

Piping
- Sands and gravels have high hydraulic conductivities (10⁻¹ to 10⁻³ cm sec⁻¹)

- Glaciolacustrine sands and clays have low hydraulic conductivities (10⁻³ to 10⁻⁷ cm sec⁻¹)

- Sapping erodes sand (high hydraulic material) to form a pipe

- Pipe focuses water into and expands pipe network

- Eventually pipe cannot support overlying sediment and collapses forming a window

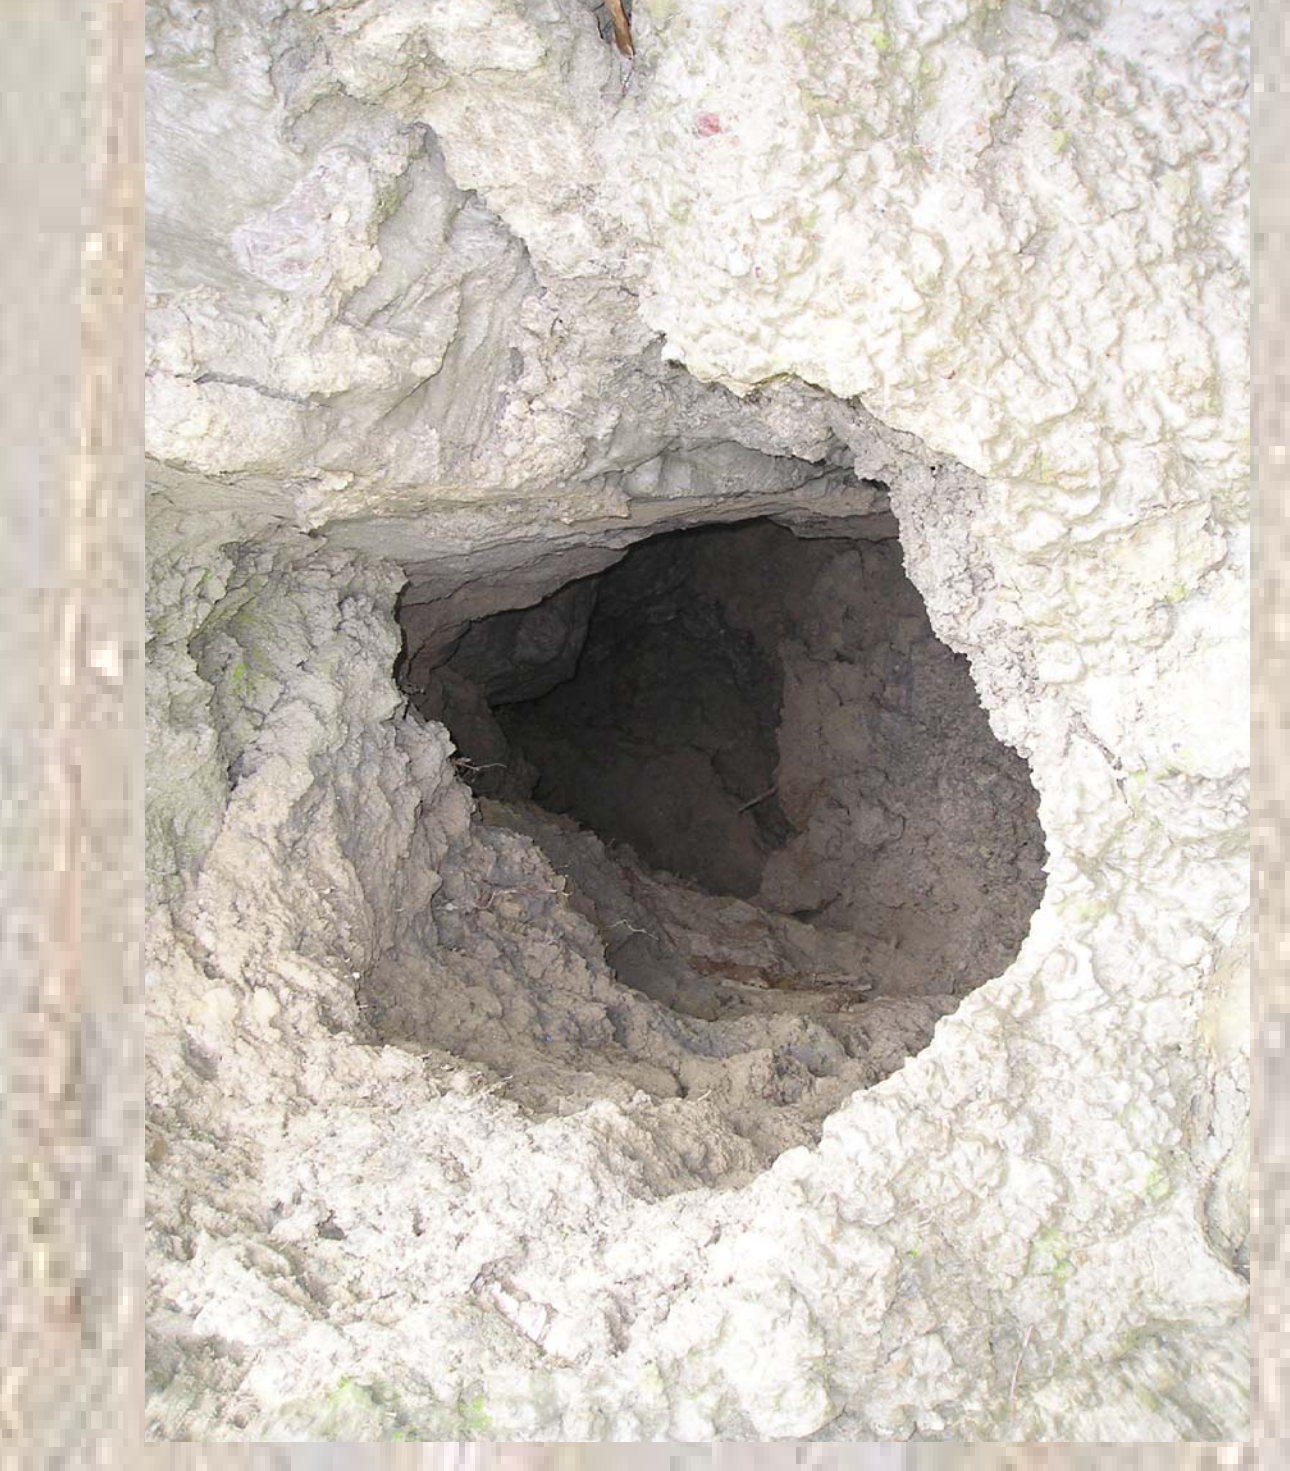
Intact pipe outlet on hillslope

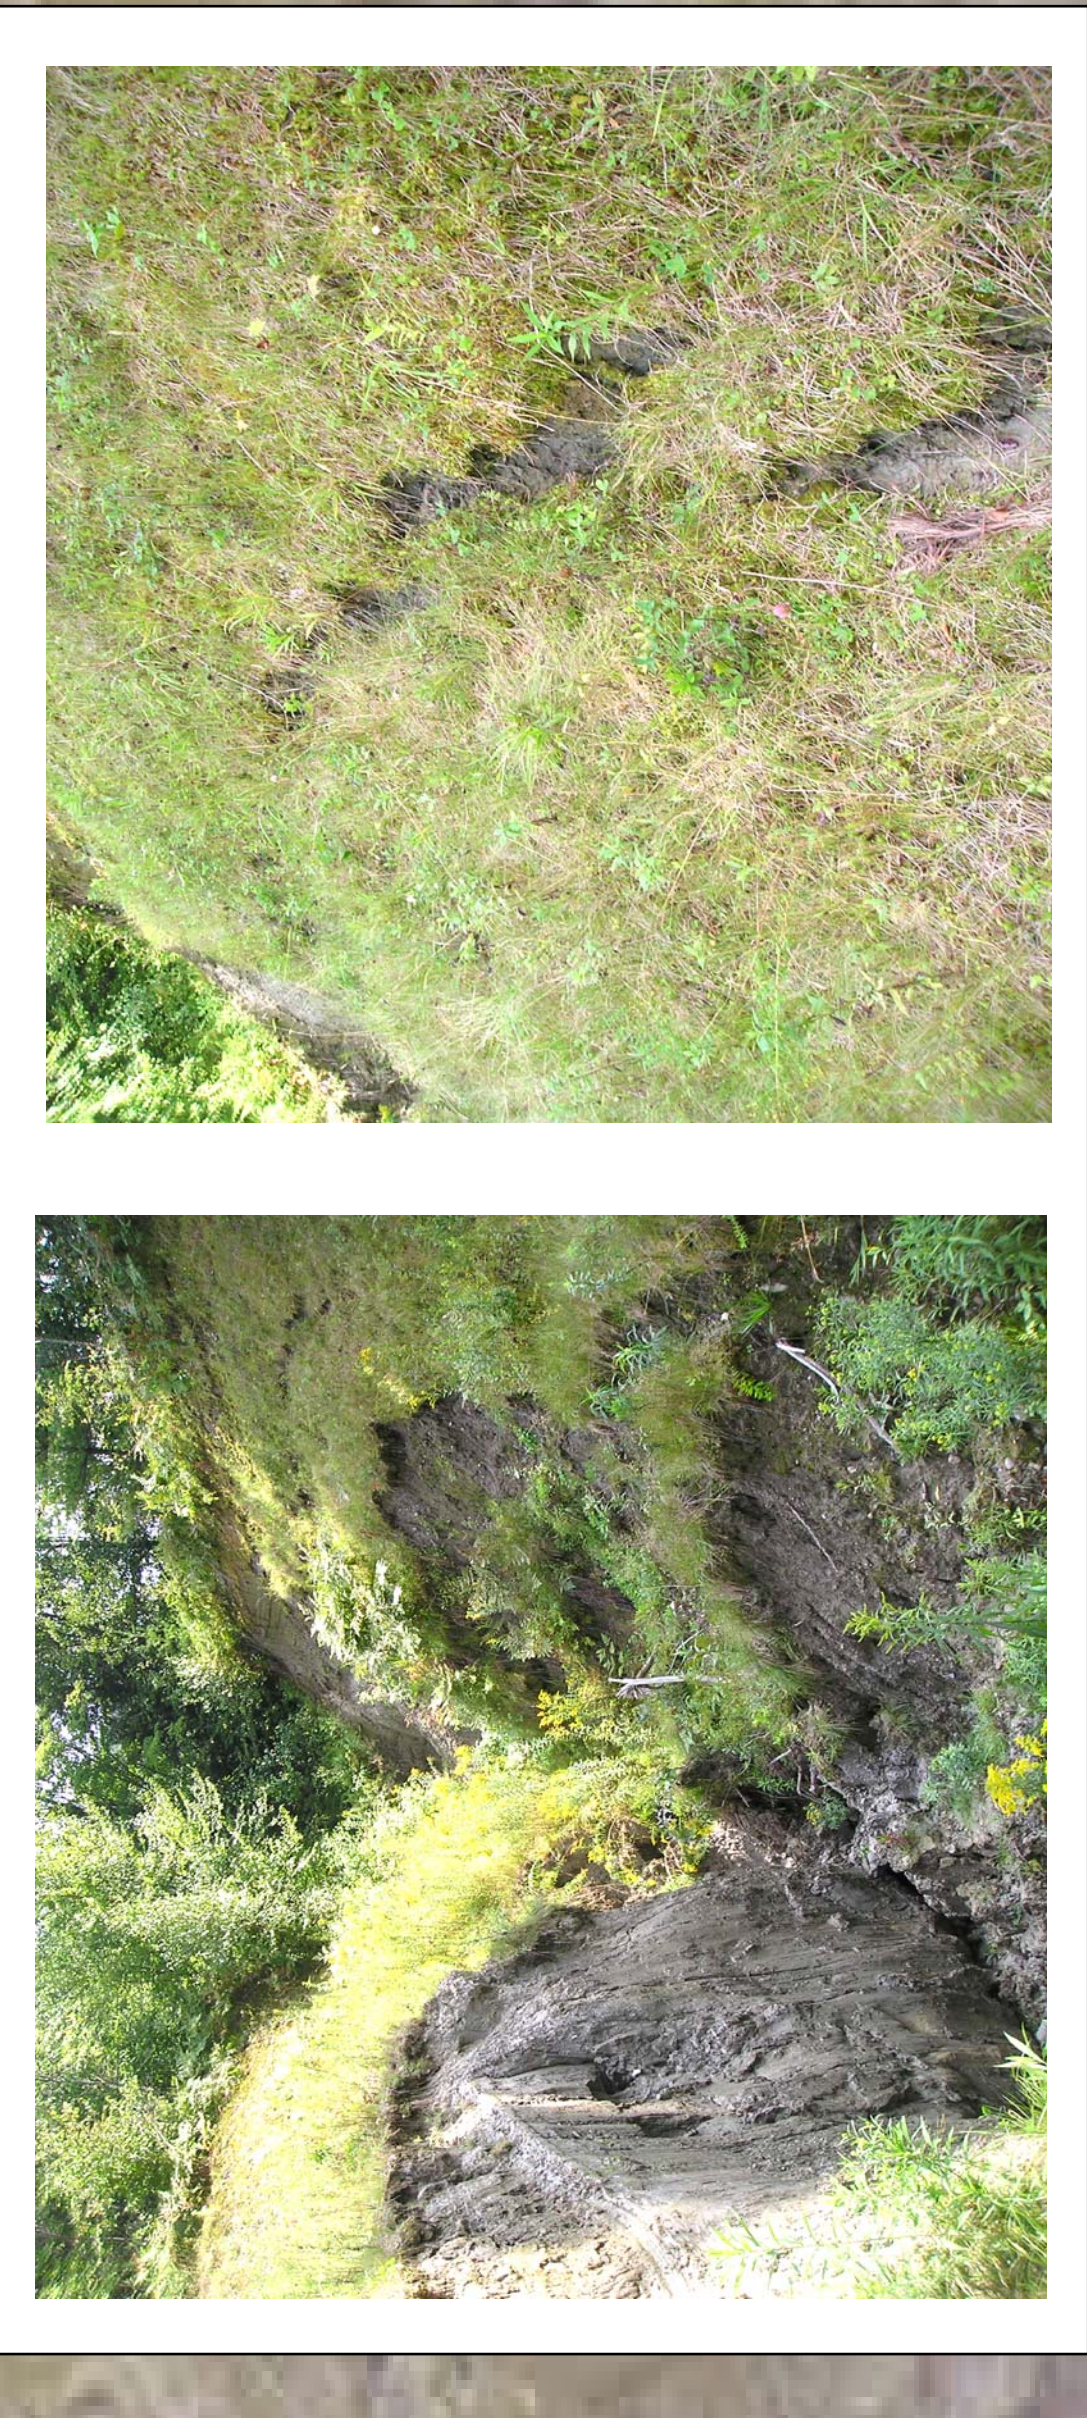
- gravitational slump and toppling dominate gully expansion

- erosion continues in asymmetrical pattern

- toppling on north side results in vertical walls

- slumping on south side results in slope angles near angle of repose

- asymmetry result of saturation and high pore pressures on the north slope and a low waterable and drier sediments on south slope

Asymmetrical gully erosion:
Toppling on north side
Slumping on south side of gully
