HADLOCK POND DAM FAILURE: RECONSTRUCTION OF PEAK DISCHARGE AND COMPARISON TO REGIONAL FLOOD FREQUENCY

¹HERBST, Doug; ¹LYONS, Davin; ²TOCZYLOWSKI, Cortlandt; ²BRONSON, Catherine; ¹SCHINK, Noella; and ¹NICHOLS, Kyle

ABSTRACT:

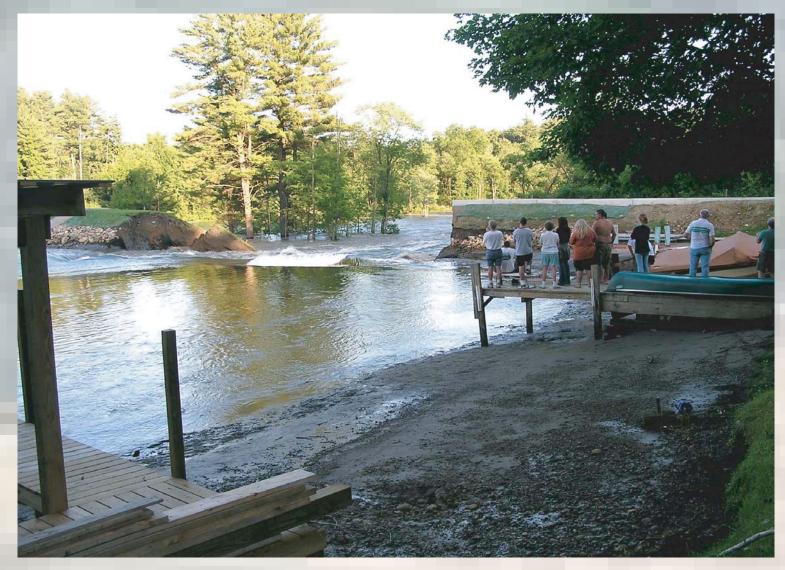
Location of Hadlock Pond, Fort Ann,

and other similar sized watersheds

that have long-term

JSGS data

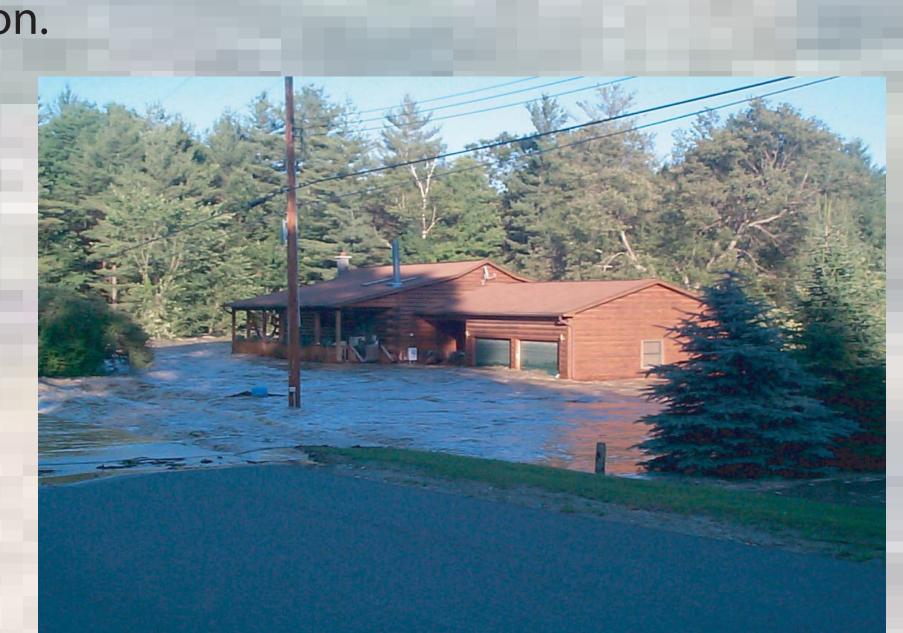
Hadlock Pond Watershed:

Surficial Geology

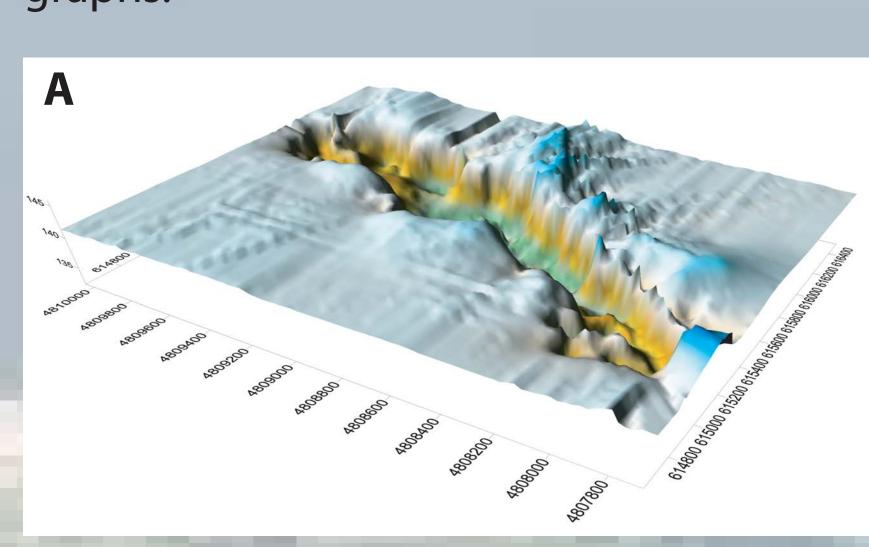
GPS data. B) Blue dots represent location of collected data. Volume \sim 3 x 10⁶ m³ before flood, 2/3 lost during dam breach.

- A. Bathymetric map (GPS)
- B. Calculated water volume using Surfer. C. Surveyed 5 channel cross sections &
- D. High water marks determined by sand deposits and reconstructed from photo-
